# London Leak Specialist

| Report type | Leak investigation and trace and access report |
| Property address | Withheld (Marylebone, NW1, City of Westminster) |

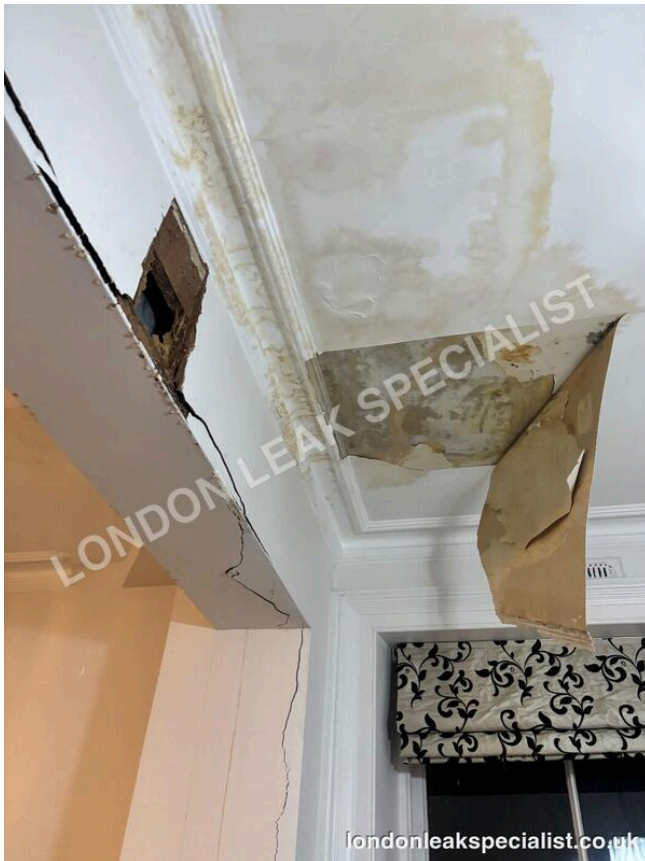
Water had continued to pass into the flats below despite the isolation of Flat A. In Flat C the boiler was located and the pipework examined. The pipes run beneath the concrete floor, not through the ceiling. The ceiling area where water was mainly coming through was opened and inspected. No pipework was found there; the only significant item in the accessible area was a steel beam.

open-plan room below may allow water to spread over a wider area of ceiling. This is a working assessment only and is unconfirmed.

Photo 1. Ceiling opened where water was coming through in the flat below, with the boxed-in steel beam beside it.

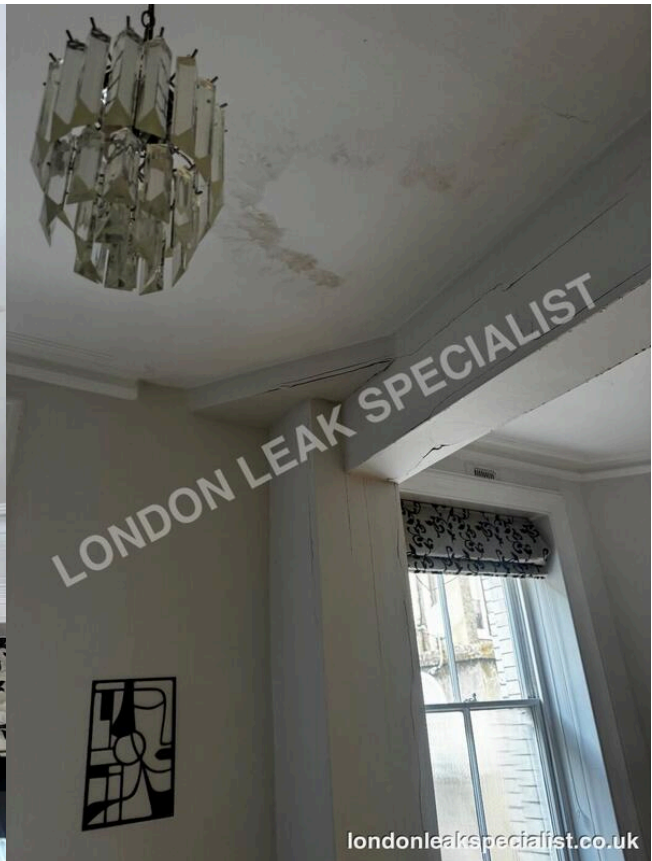
Photo 2. Water staining on the ceiling of one of the affected flats.

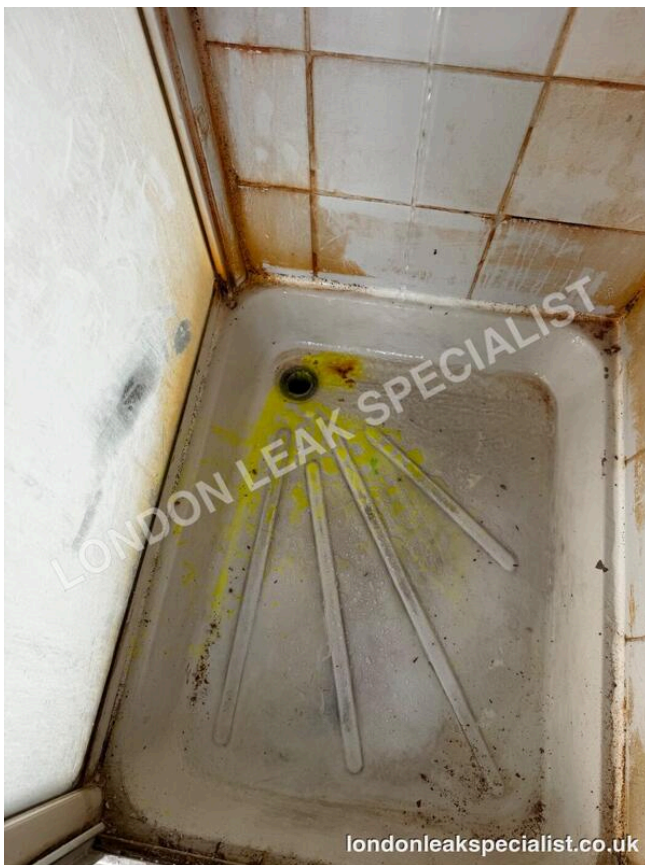
**Tracer dye test.** Yellow tracer dye was introduced into the accessible waste pipework to help eliminate or confirm the waste system as a source. Occupants of the flats below were asked to watch for yellow-coloured water over 24 hours. A second dye of a different colour can be used if the result is inconclusive.

Photo 3. Yellow tracer dye run into a shower tray waste during the waste pipe test.

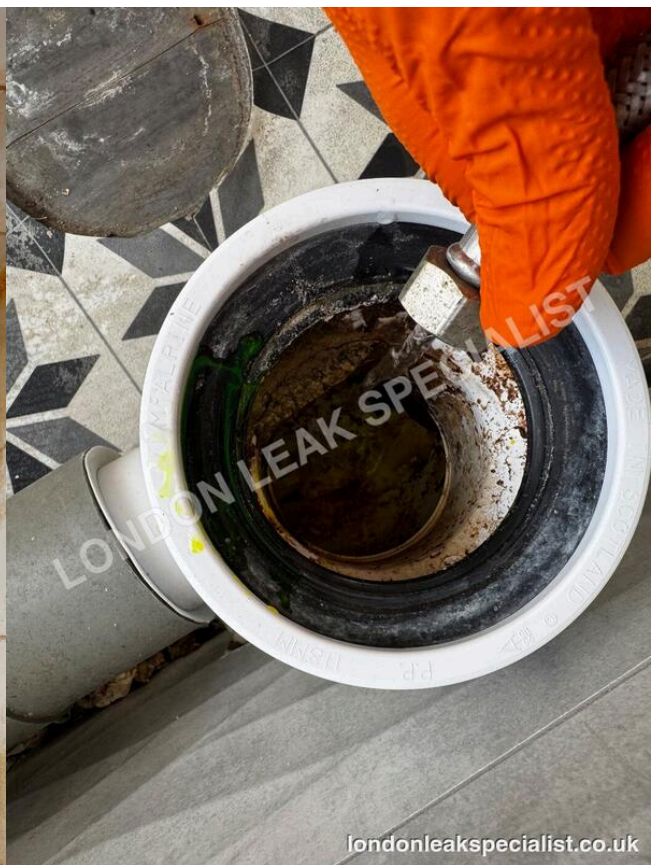
Photo 4. Tracer dye being introduced at an open waste outlet.

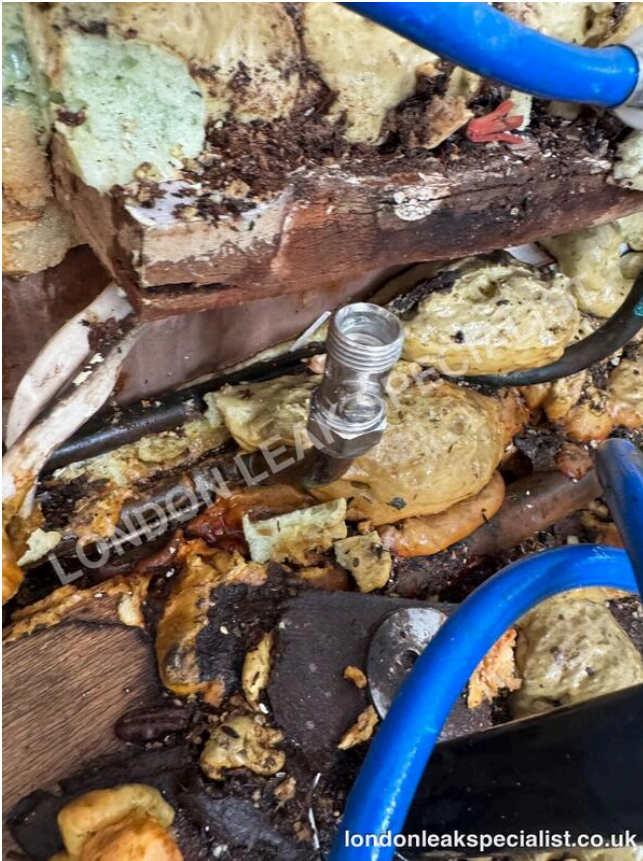
Most of the bathroom and kitchen fittings in Flat A had already been removed. The visible plumbing was pipework protruding from walls with isolation valves fitted. The supply to the flat had been off for several days. Substantial evidence of earlier water damage was found where both bathroom basins, the kitchen sink and the toilet had been installed, and the flooring in those areas was heavily damp.

Photo 5. Damp debris and an isolation valve where bathroom fittings had been removed.

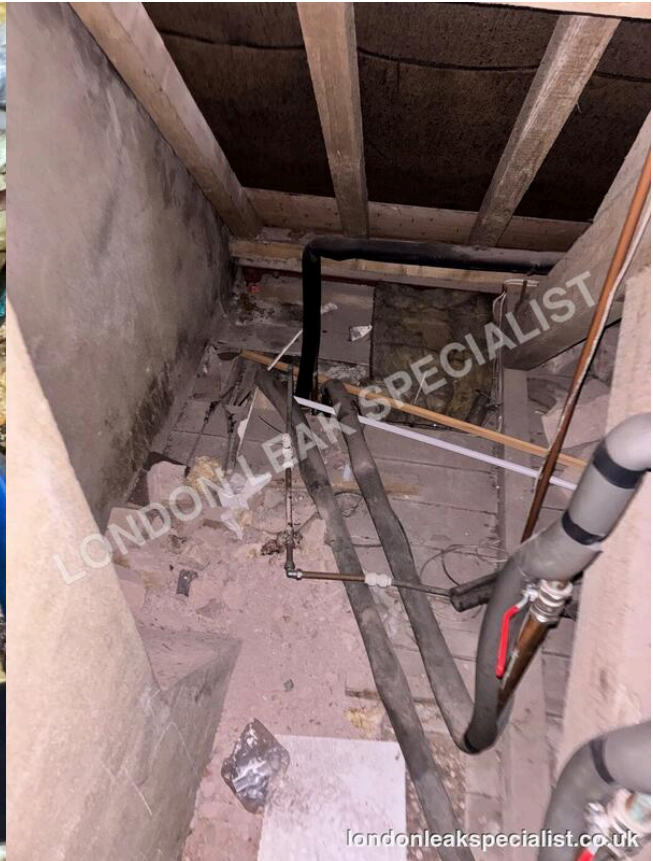
Photo 6. Lagged pipework and valves in an accessible void.
