## Leak Detection Investigation Report

| Property | Withheld (restaurant with residential flat above, Harlesden, NW10) |
| Investigation type | Visual inspection and tracer dye flood test |

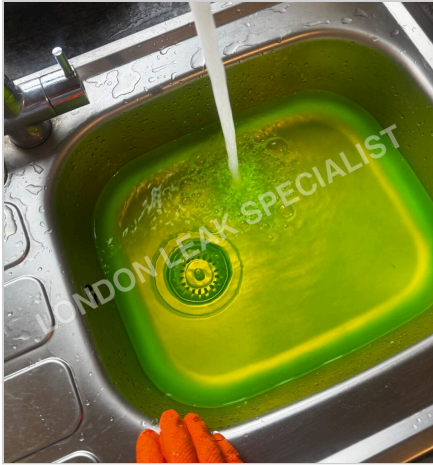
The kitchen sink was filled with warm water containing tracer dye. The use of dyed water allowed the movement of water to be monitored during the investigation. The sink was then allowed to discharge in a controlled manner while the area below was observed. The test continued for approximately 15 minutes, during which water ingress was observed coming through the ceiling of the restaurant below.

Tracer dye test: the upstairs kitchen sink filled with warm dyed water

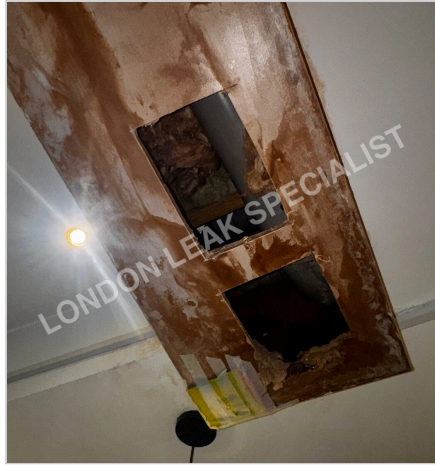
The controlled test confirmed that the reported leak could be reproduced when the upstairs kitchen sink was discharged. Following confirmation of the ingress, an inspection opening was formed in the restaurant ceiling within the boxed-in section containing the waste pipework. Once the ceiling had been opened, active dripping was observed from the area of the main soil and waste stack.

Inspection openings in the boxed-in ceiling section below

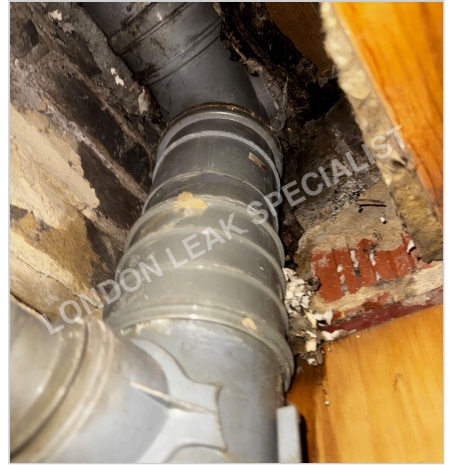
The observed dripping established a direct correlation between the upstairs kitchen sink test and the water entering the restaurant ceiling. The affected stack area was found to be partially concealed within the brickwork and partially enclosed within the ceiling void. This restricted access from the restaurant side and prevented the full length of the affected section from being exposed during the visit.

The main soil and waste stack exposed in the ceiling void

3. Expose the affected section of the main soil and waste stack from the agreed access route and inspect the pipework fully so that the precise defective joint, connection or section can be identified and permanently repaired or replaced.

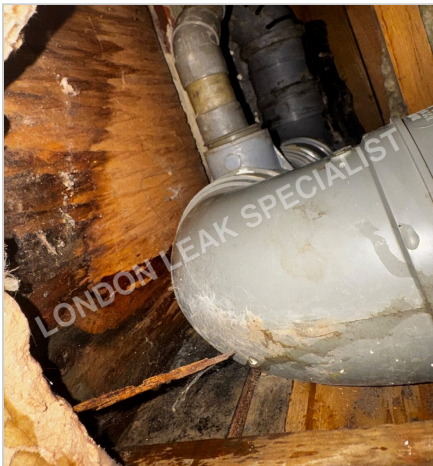
The confirmed source area associated with the intermittent water ingress is the concealed main soil and waste stack or one of its connections serving the residential flat above the restaurant. This was established by reproducing the leak through controlled discharge of the upstairs kitchen sink and observing active dripping from the stack area after the restaurant ceiling was opened.

Stack, branch connection and water-stained timber in the void

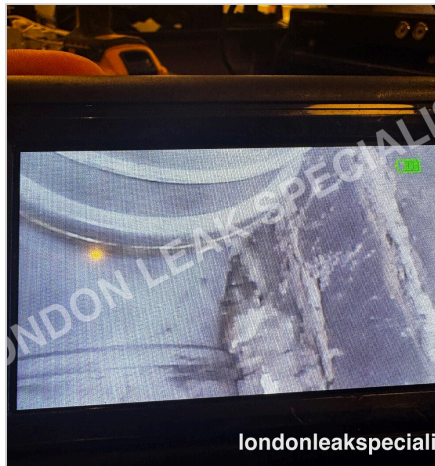
Inspection camera view inside the concealed void

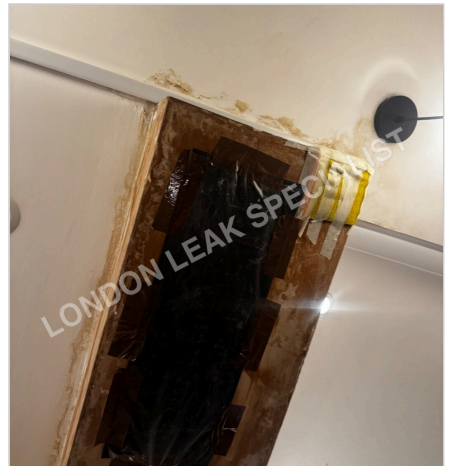
The boxed-in section after the inspection, opening covered
