## Leak Detection: Detailed Findings Report

| Property | Withheld. Flat, London NW5 |
| Inspection date | 28 September 2026 |
| Cause confirmed | Failed shower tray and enclosure sealing |

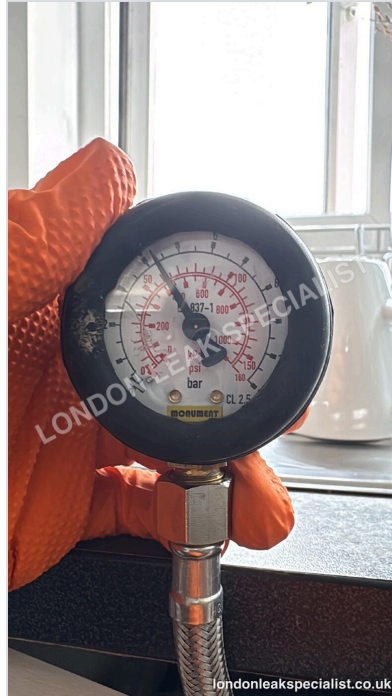
- Hot water: A slight pressure drop was recorded during testing.
- Cold water: A more noticeable pressure drop was recorded compared with the hot-water system.

Although the pressure results indicated some loss within the systems, no visible or active leak could be identified from the exposed pipework or visible plumbing fittings. Cold water supply pressure loss was later attributed to a valve on a toilet cistern.

Photo 1. Pressure gauge connected to the isolated supply during the hot and cold pressure tests.

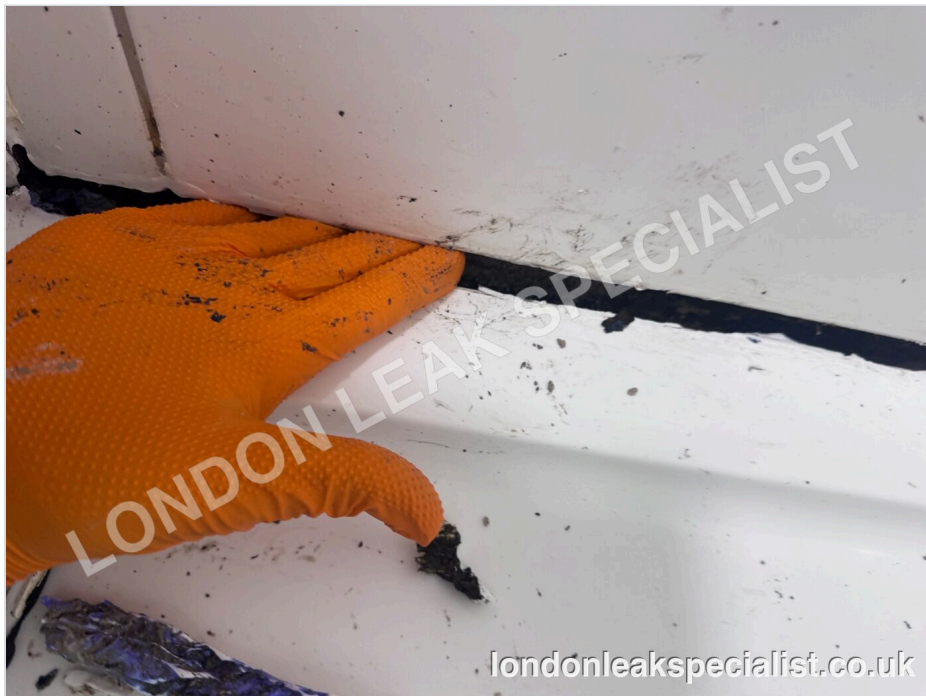
During the shower test, water was observed penetrating around the shower tray/base and through the surrounding mastic/sealing.

The evidence indicates that the primary source of the water damage is failure of the shower enclosure/tray sealing and surrounding tiled area, rather than an active leak from the concealed hot or cold-water supply pipework.

Photo 2. Failed mastic and an open joint at the shower tray edge.

The existing failed mastic/sealant around the shower was carefully removed from the affected areas.

A temporary new mastic seal was then applied around the shower tray to reduce further water penetration and provide a temporary watertight seal.

- Apply new suitable waterproof grout.
- Apply a continuous sanitary-grade waterproof mastic seal around all relevant junctions, particularly around the shower tray and enclosure.

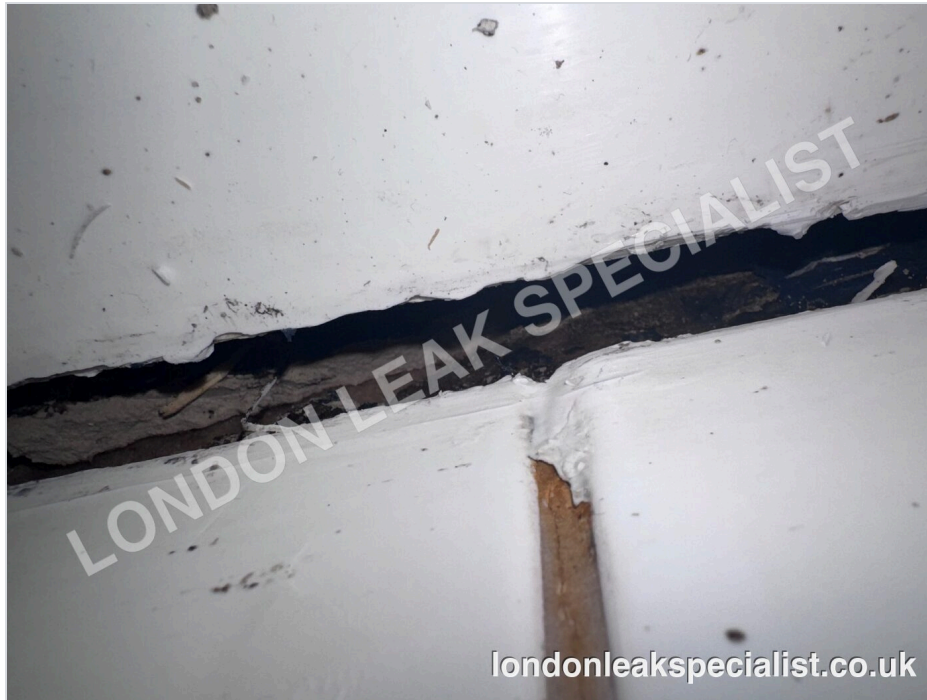
- The timber/floor structure beneath the shower was heavily saturated.
- The plasterboard within the concealed area was wet and water damaged.
- There were clear signs of prolonged moisture penetration.
- The concealed area was significantly damp compared with the surrounding accessible areas.

The water was entering the concealed area beneath the shower tray and saturating the timber and surrounding materials.

Photo 3. Opened joint at the tray, with the timber beneath visibly stained.

- Inspect the underlying substrate, plasterboard and timber for the full extent of water damage.
- Replace any saturated or damaged plasterboard/timber where required.

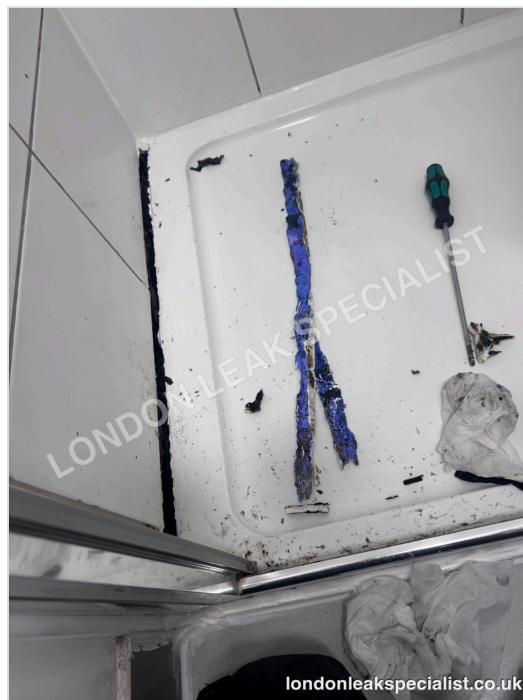
Further confirmation was provided by the presence of blue tracer dye beneath the shower tray. This tracer dye had been introduced during a previous investigation and had subsequently migrated into the area beneath the shower, confirming that water from the shower area was penetrating into the concealed structure.

Photo 4. Blue tracer dye from the earlier visit, found in the tray void.

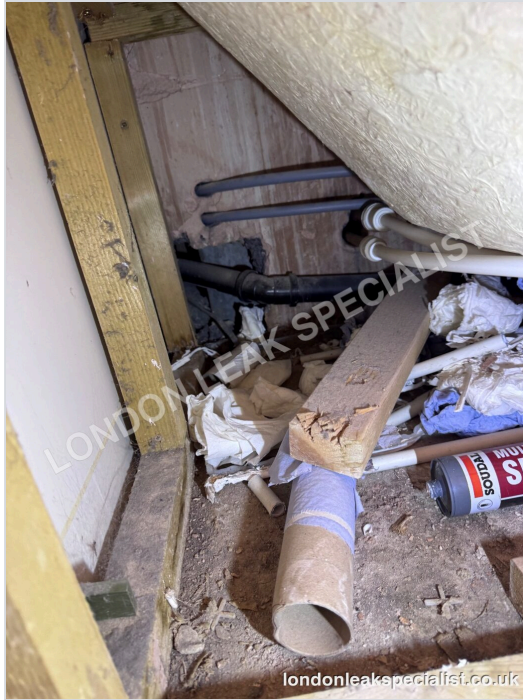
Photo 5. Targeted access beside the bath showing the supply and waste pipework.
