# London Leak Specialist

## Leak Detection & Repair Report

**Client** Withheld  
**Property** Withheld (flat, Shepherds Bush, W12)  
**Inspection date** September 2026

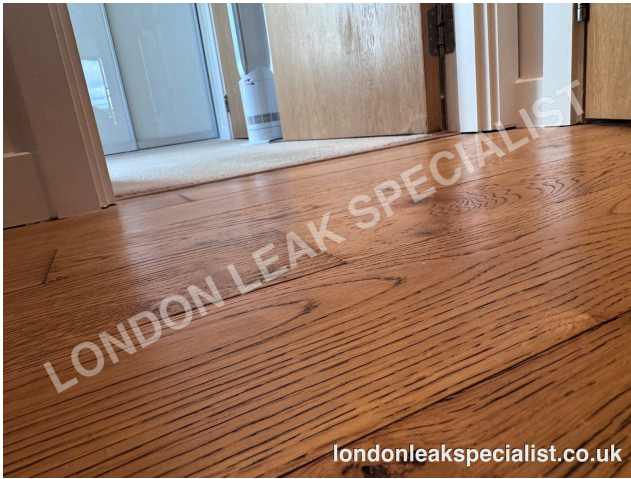
Damp rising from flooring with underfloor heating
