# London Leak Specialist

**Client** Withheld  
**Property** Withheld (North London, N11)  
**Inspection date** 2026-10-08

## Leak Detection Report – Findings, Investigation and Recommendations

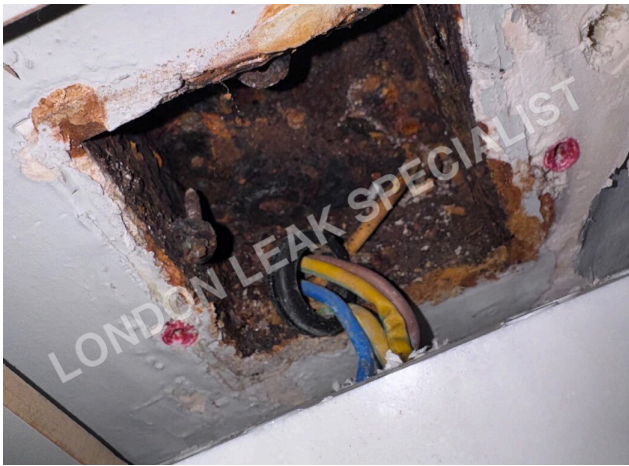
The fact that water had reached areas associated with the electrical installation was also significant and demonstrates the extent to which the water had migrated through otherwise concealed areas.

Photo 1: Corroded back box of the wet socket that first raised the alarm

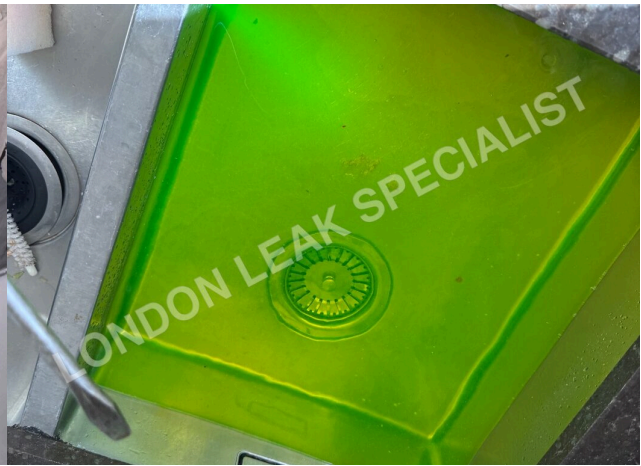
As part of the investigation, the drainage system was also considered and tracer dye testing was undertaken/considered where relevant.

Photo 2: Tracer dye run through the kitchen sink

The occupants should monitor the affected areas following our attendance for any appearance of coloured dye, fresh water staining or renewed moisture.

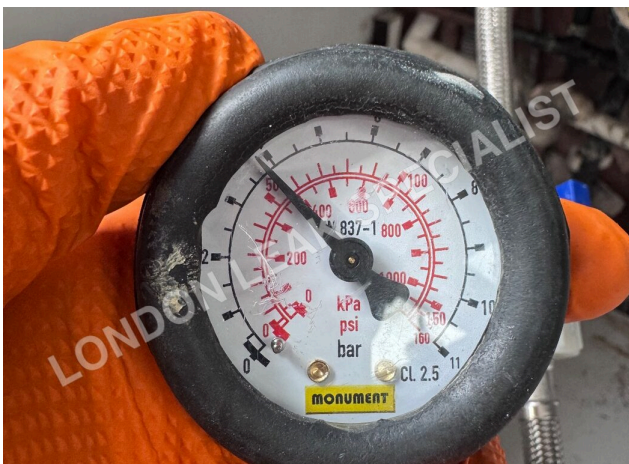
During the **initial pressure test, a pressure drop was recorded on the cold-water circuit.**

Following isolation of the washing machine valve, **the previously recorded pressure drop was no longer present.**

Photo 3: Pressure gauge during the cold-water test

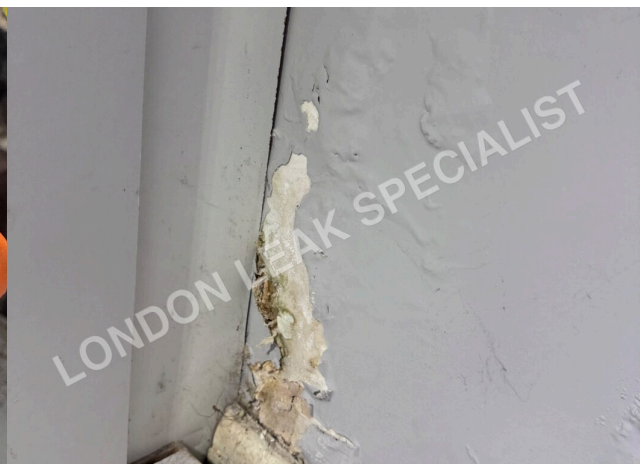
In this case, the damage extended along the skirting of the rear kitchen wall, behind the food cupboard, beneath the floor and towards the opposite side of the affected area, including internal walls immediately behind the washing machine.

Photo 4: Salt and paint damage along the rear kitchen skirting

Given the extent of the moisture migration identified during the investigation, we recommend that the property's insurer **appoint or authorise a professional water-damage restoration and drying contractor before significant building or reinstatement works commence**.

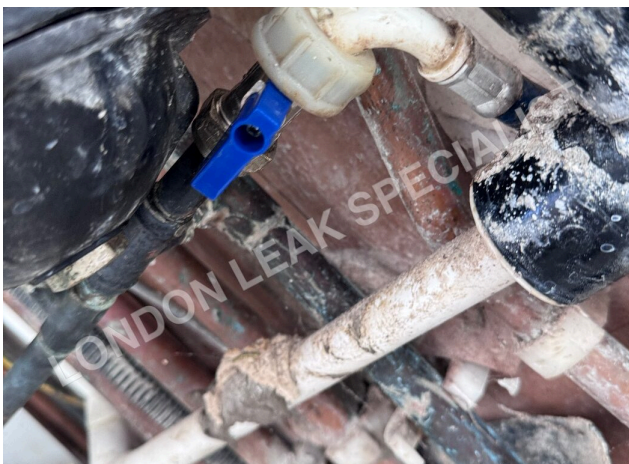
The active source of water escape was identified as the **washing machine isolation valve located beneath the kitchen sink.**

The valve was found to be slowly dripping.

Photo 5: Pipework beneath the kitchen sink where the valve sits

The defective washing machine isolation valve was replaced.

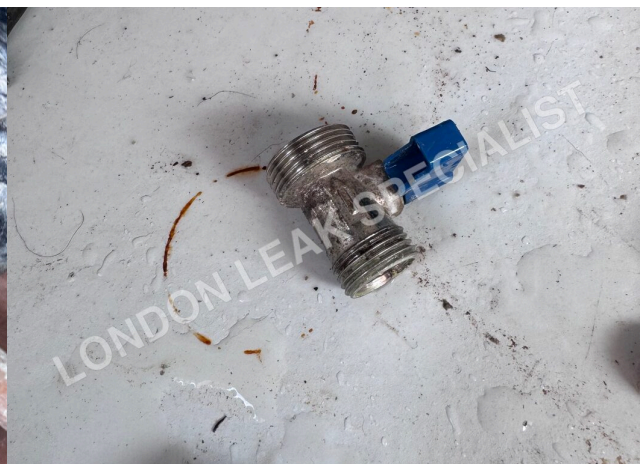
The valve was then inspected and was found to be slowly dripping.

Photo 6: The defective valve after removal

The system held pressure following the repair, with **no further pressure loss identified**.
