# London Leak Specialist

## Leak Detection & Repair Report

**Client** Withheld  
**Property** Withheld (flat, Shepherds Bush, W12)  
**Inspection date** September 2026

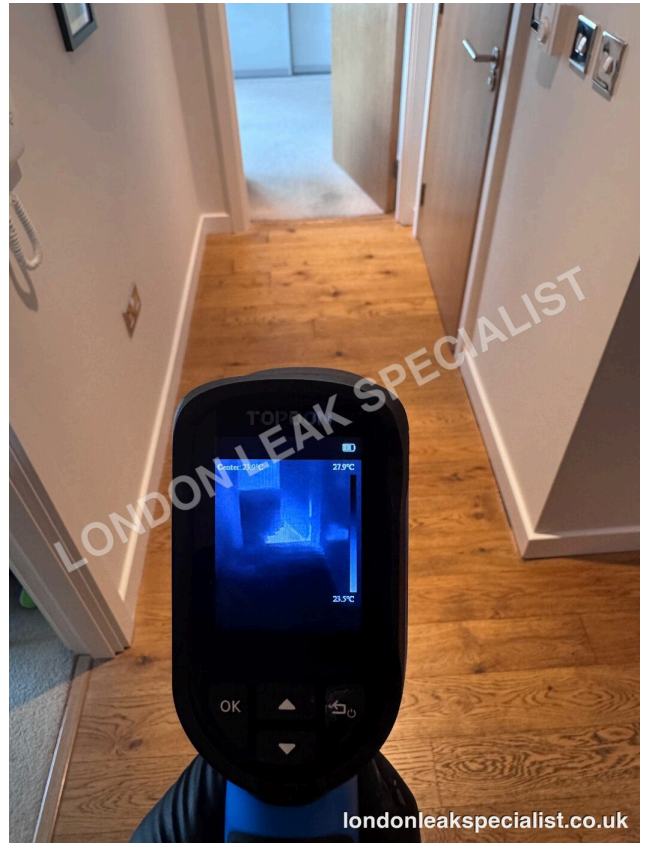
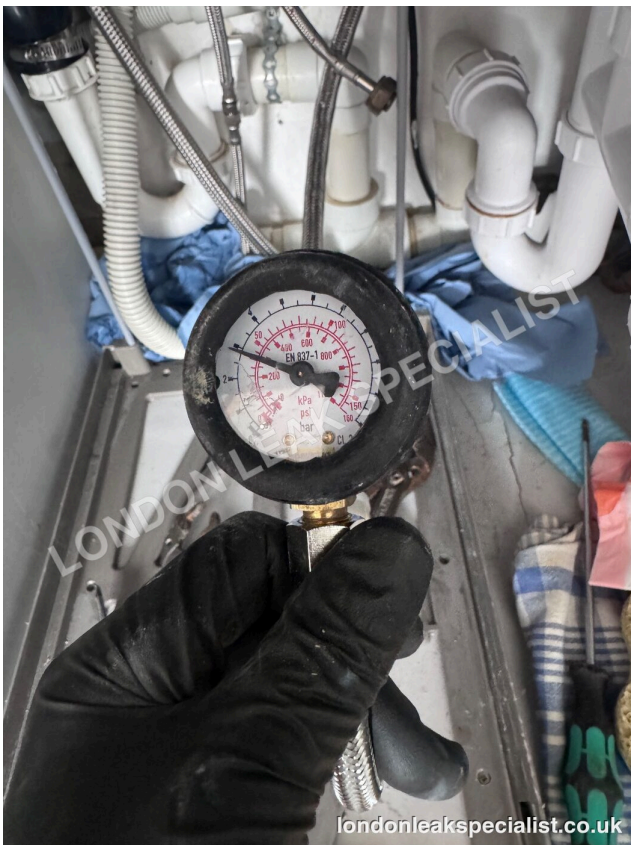
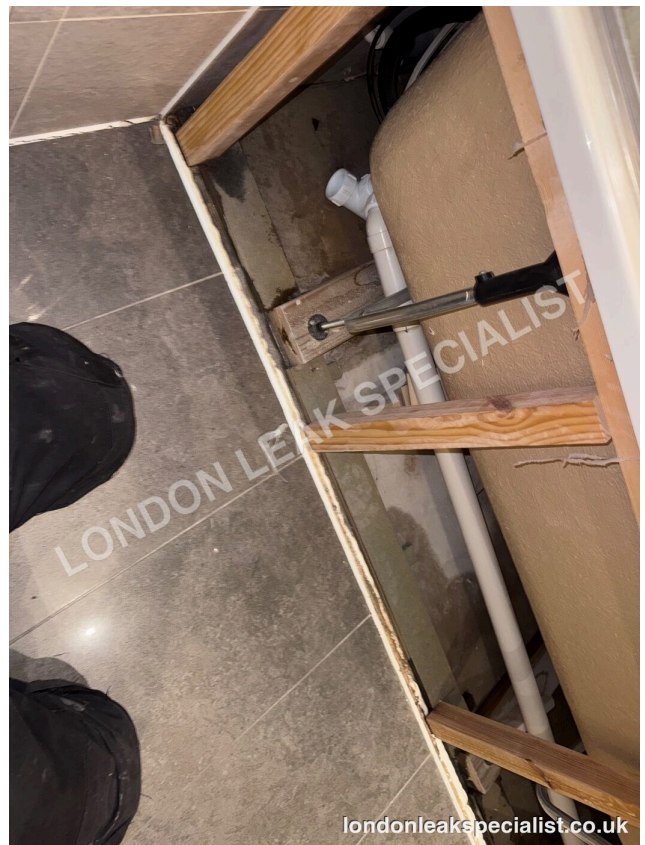
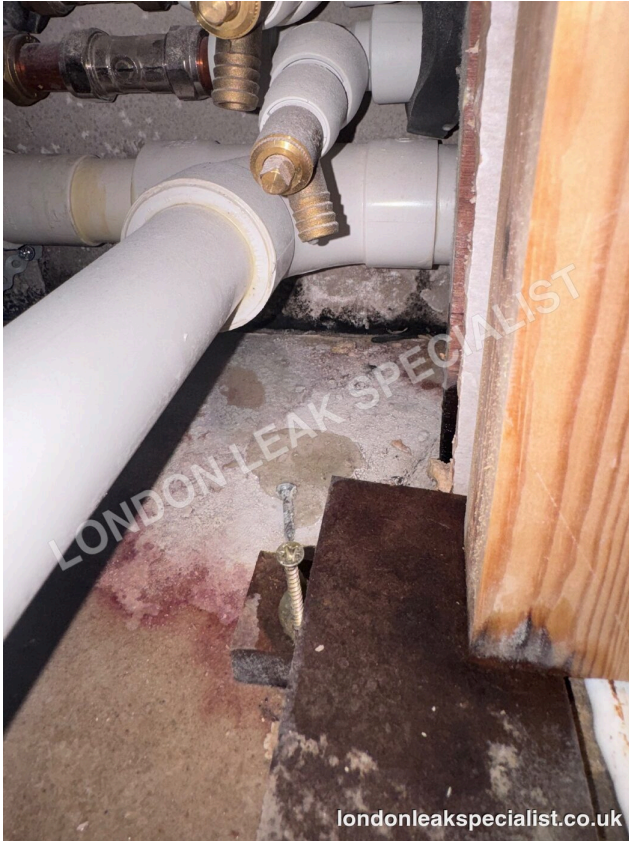
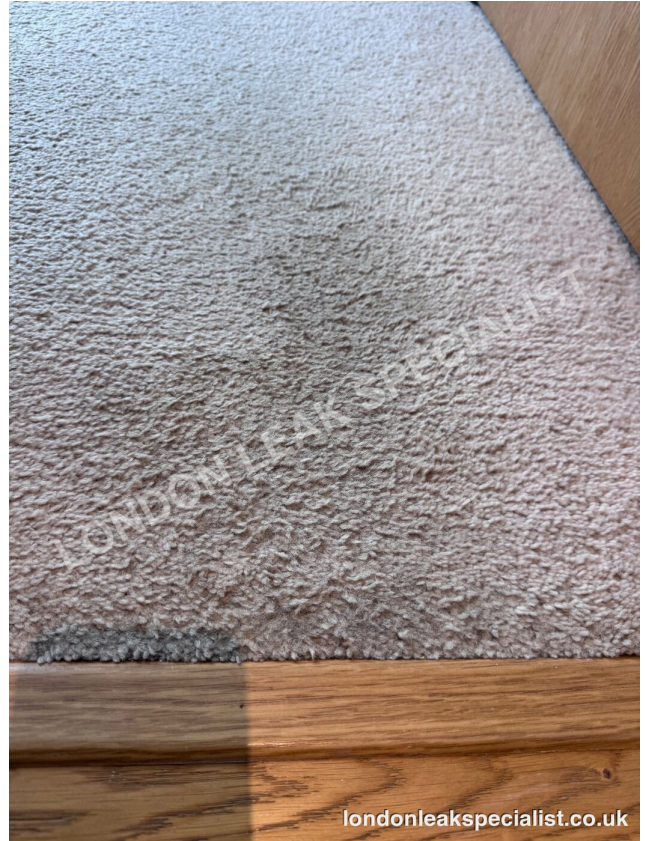
## **Photographs**

The tracer gas was escaping from a defective 15 mm drain-off valve located beneath the bath. This confirmed the source of the pressure loss identified during the cold-water pressure test.

The investigation therefore established that the reported moisture was not caused by a failure of the underfloor heating system. The source was a defective/leaking 15 mm drain-off valve associated with the water pipework beneath the bath.

Damp rising from flooring with underfloor heating

The leaking 15 mm drain-off valve was then replaced with a new valve.
